# **Forensic Building Science, Inc.**

## **Storm Damage Report**

Southgate Townhome Association  
Multiple addresses on East Ave,  
Butternut Lane,  
Wysteria Lane,  
Teak Lane,  
Ivy Court,  
and Acorn Drive  
Streamwood IL, 60107

**FIELD REPORT FOR INITIAL STORM DAMAGE INVESTIGATION**

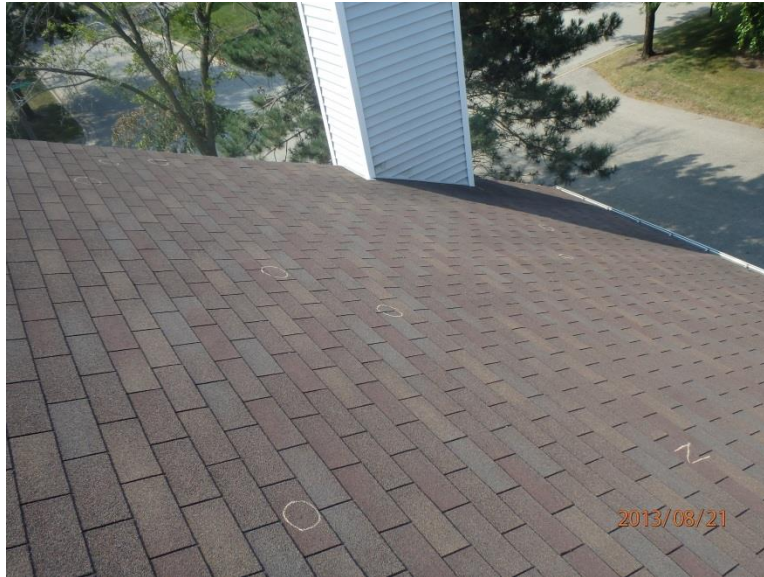
248 – 254 Butternut Lane (Building 7):

- Front elevations face east and west (garage and front doors)
- Multiple impacts to various metal wrap on the west facing side.
- Multiple impacts to window trim on the west facing side.
- Multiple impacts to HVAC condenser coils on the north facing side.
- Impact damage on roof vents – more damage on west facing vents.
- 3 impacts identified on the west facing vinyl siding.
- 2 impacts identified on the north facing vinyl siding.
- 20+ impacts identified on the west facing lower right elevation roof.
- 10+ impacts identified on the east facing lower right elevation roof.
- 5+ impacts identified on the lower west facing left elevation.
- 5+ impacts identified on the lower east facing left elevation roof.
- 5+ impacts identified on the upper west facing roof.
- 5+ impacts identified on the upper east facing roof.

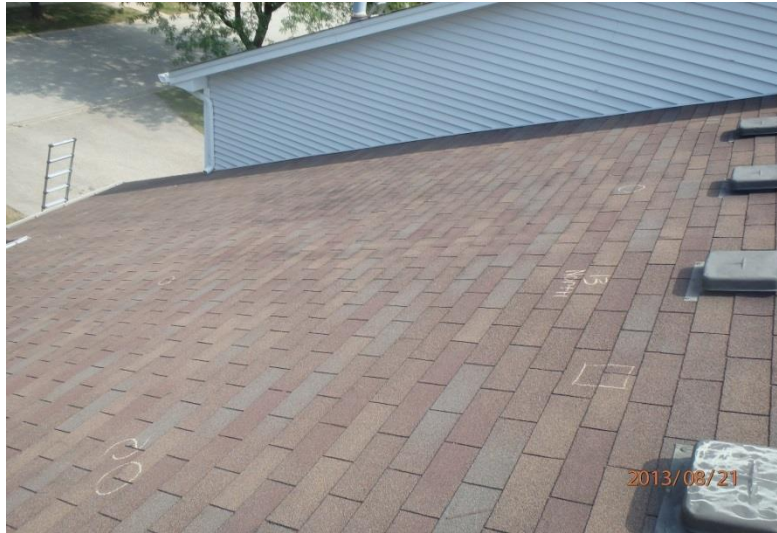
201 – 203 Ivy Court and 527 – 531 East Avenue (Building 30):

- Front elevations face north and south (garage and front doors)
- Impact damage to gutters and downspouts.
- Rust stains on chimney cap.
- Impact damage to metal wrap on back elevation.
- Impact damage to metal trim.
- Impact damage to roof vents.
- Torn shingles.
- 32 impacts identified on the west facing vinyl siding.
- 1 impact identified on the south facing vinyl siding.
- 10+ impacts identified on the north facing lower right elevation roof.
- 5+ impacts identified on the south facing lower right elevation roof.
- 5+ impacts identified on the north facing lower left elevation roof.
- 5+ impact identified on the south facing lower left elevation roof.
- 1 impact identified on the upper roof slopes.
- Multiple soft spots on roof deck.

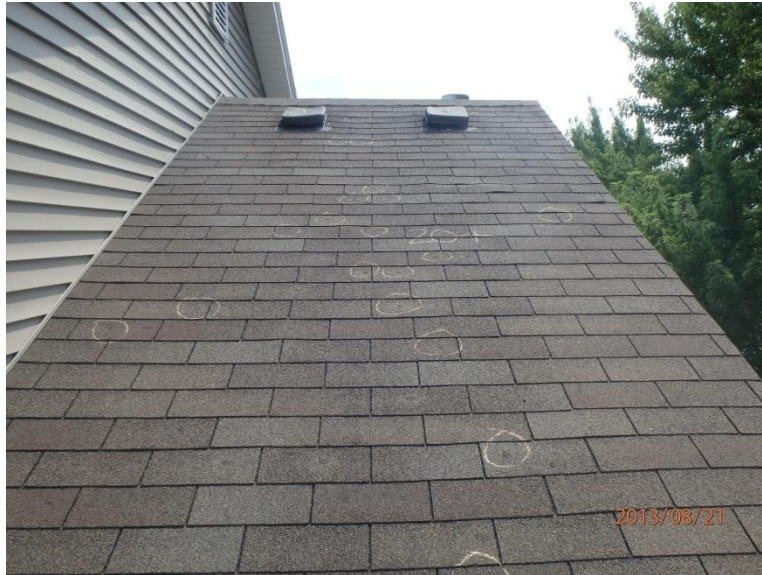
533 – 539 East Avenue (Building 31):

- Front elevations face northwest and southeast.
- West and Southwest Multiple impacts to metal wrap.
- Multiple impacts to gutter downspouts.
- Impact damage to metal flashing.

- Severe impact damage to roof vents – a majority of the damage was on the northwest facing side.
- Torn shingles.
- Tree in contact with roof.
- Temporary repair work done to shingles with caulk and nails.

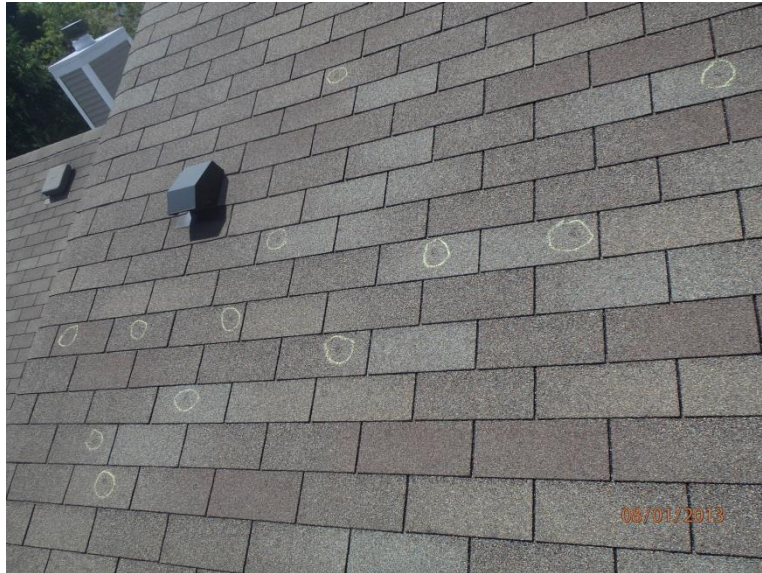
216 – 222 Teak Lane (Building 35):

- Front elevations face southwest and northeast.
- West impact damage to roof vents.
- Unsealed shingle tabs.
- 17 impacts identified on the northwest facing vinyl siding.
- 10 + impacts identified on the southwest facing lower left elevation roof.
- 5+ impacts identified on the northeast facing lower left elevation roof.
- 10+ impacts identified on the southwest facing lower right elevation roof.
- 10+ impacts identified on the northeast facing lower right elevation roof.
- 20+ impacts identified on the upper southwest facing roof.
- 25+ impacts identified on the upper northeast facing roof.

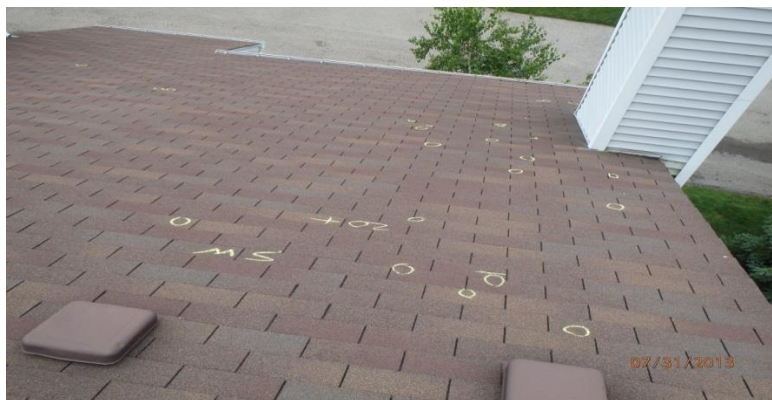
225 – 231 Teak Lane (Building 42):

- Front elevations face northeast and southwest.
- Multiple impacts identified to HVAC condenser coils.
- Multiple impacts identified on metal wrap.
- Multiple impacts identified on gutter downspouts.
- Multiple impacts identified on metal trim.

- Multiple impacts identified on with and door screens.
- Severe impact damage to roof vents.
- Impact damage to through the matt was identified on multiple shingles.
- 9 impacts identified on the northwest facing siding.
- 1 impacts identified on the southwest facing siding.
- 20+ impacts were identified on the southwest facing upper roof.
- 20+ impacts were identified on the lower northeast facing roofs.
- 65-70 impacts identified on roof.
